POST-TENSIONING TENDON REPAIRS OF TWO SEGMENTAL CONCRETE BRIDGES

I-526 James B. Edwards Bridge
over the Wando River

N-2 Missouri River Bridge

**Post-Tensioning Tendon
Inspection and Repairs**

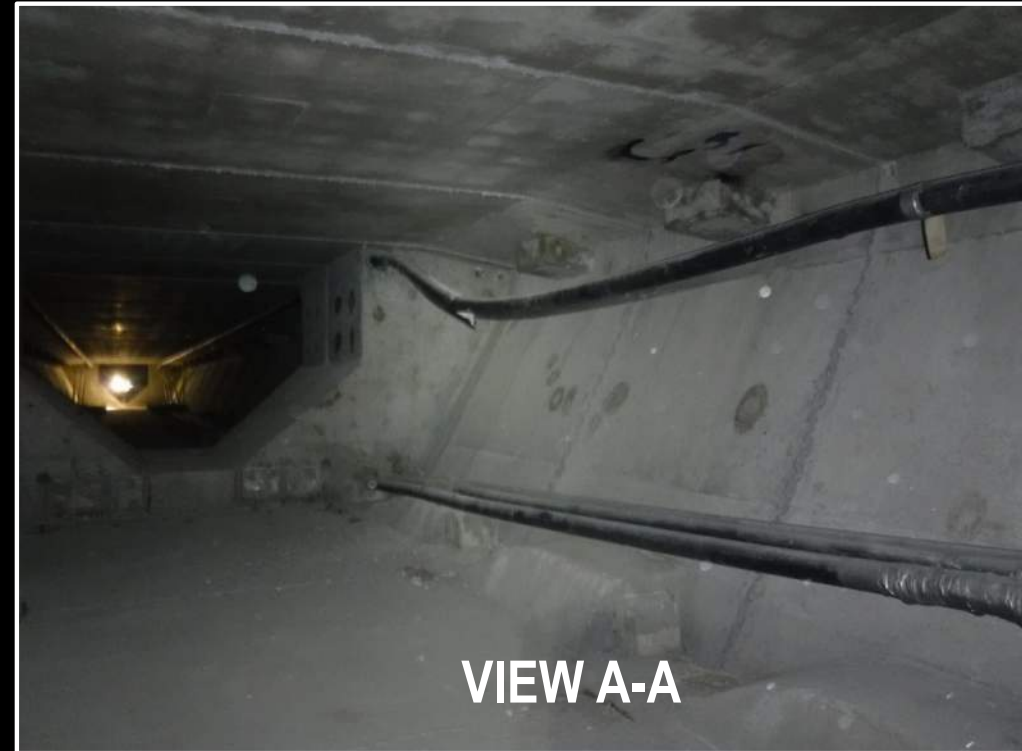
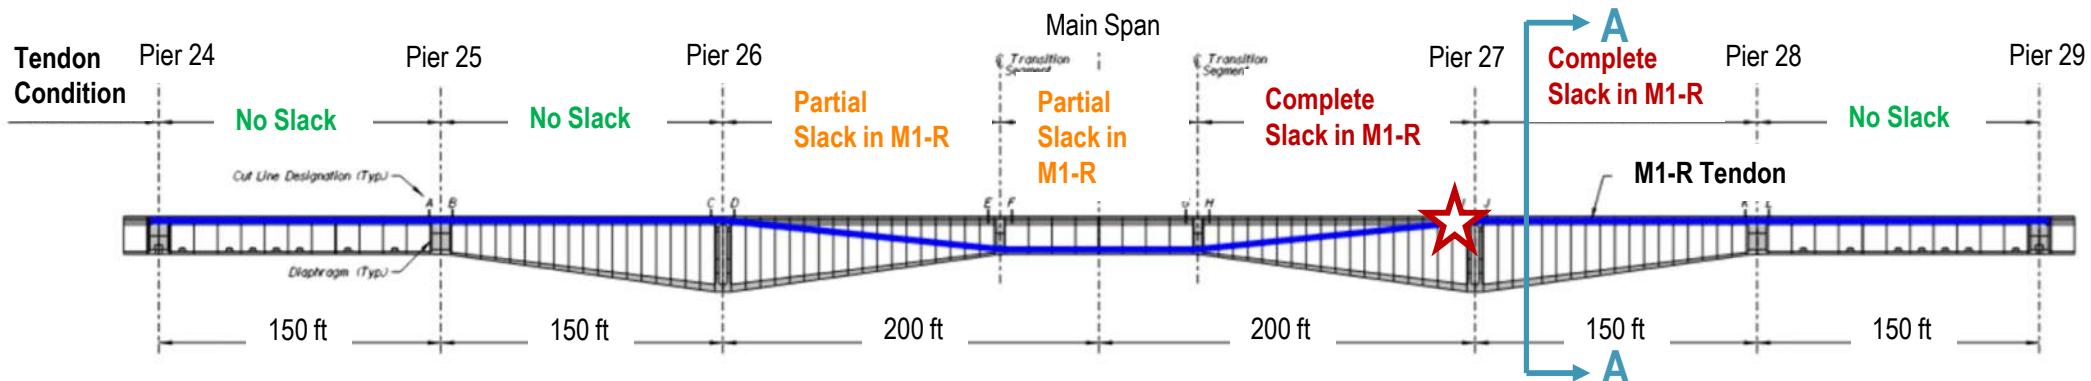
M1-R Tendon Ruptured

- 19 Strand External Tendon
- 1,010 ft long
- No other distress evident

- Near daily inspection
- Installed crack monitors at key locations
- Engaged HDR to Model and analyze main span unit
- **Closed one traffic lane to reduce load and provide a work zone on the deck**
- Installed one supplemental tendon
- Detensioned and replaced the ruptured tendon

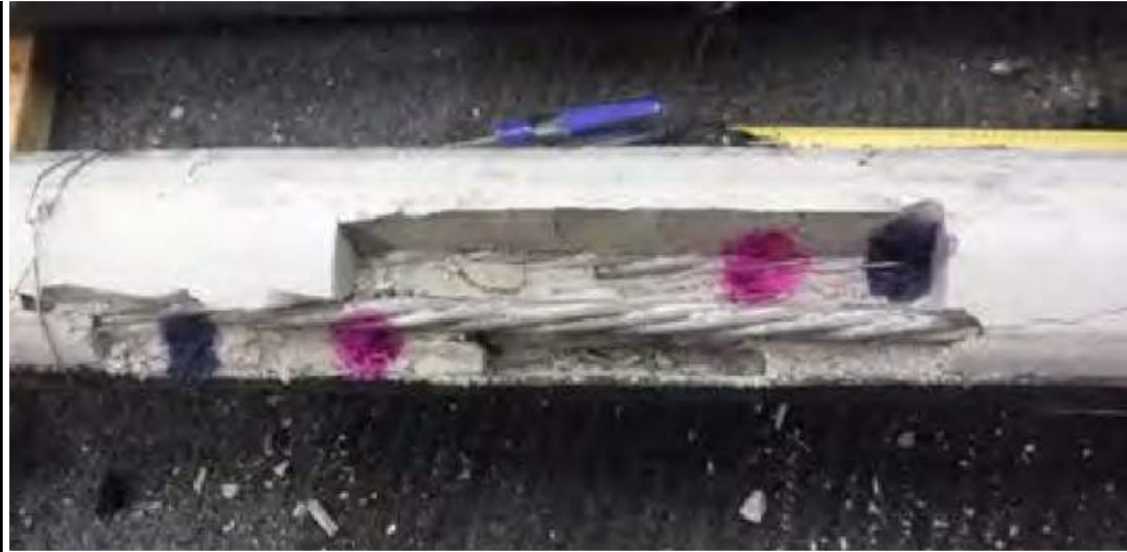
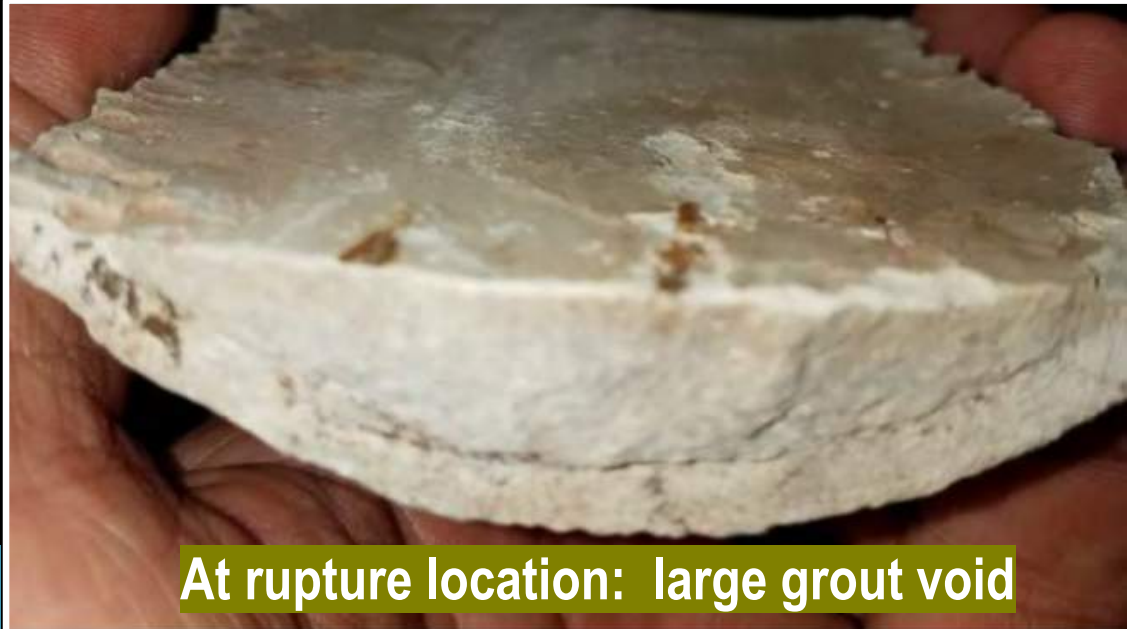
At rupture location: large grout void

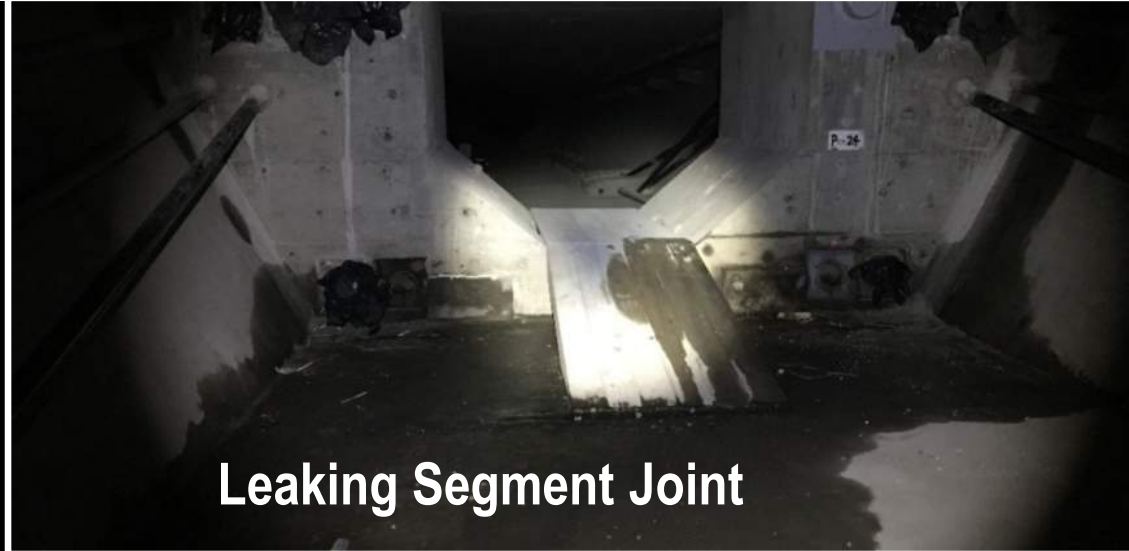
- Severe corrosion of the strand
- Duct was approximately 80% empty
- Very low pH (around 5)
- Water infiltration

Leaking Segment Joint

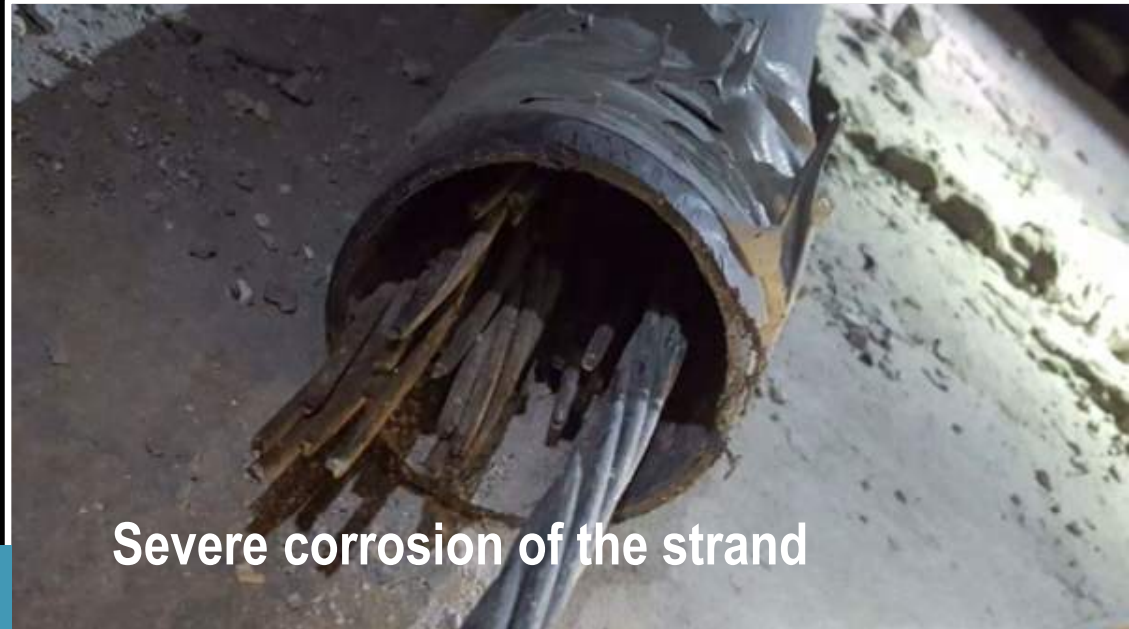
Severe corrosion of the strand

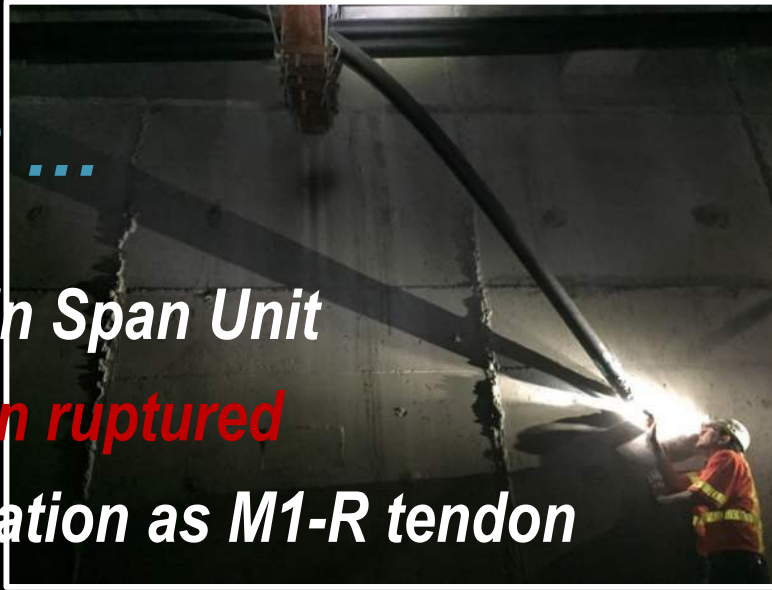
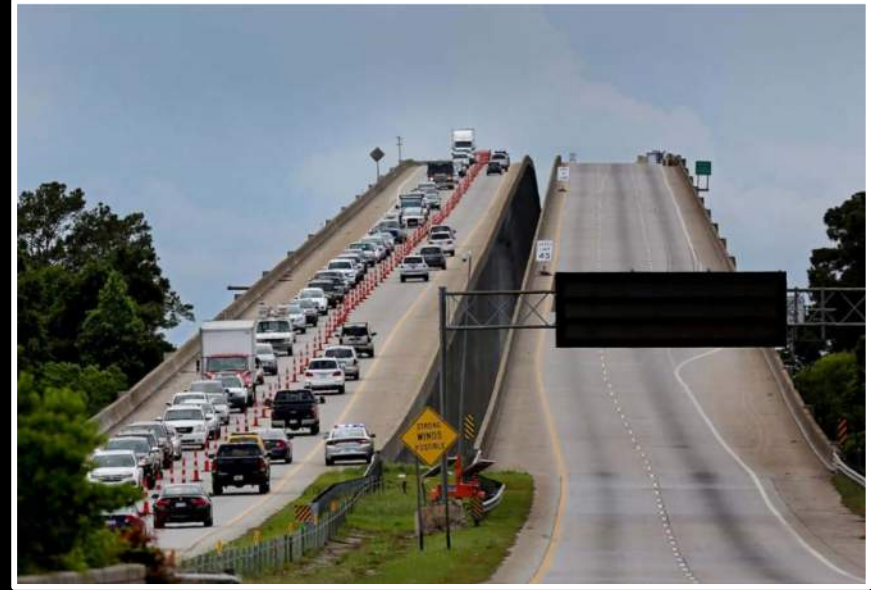
Again – Main Span Unit
M4-L Tendon ruptured
at same location as M1-R tendon

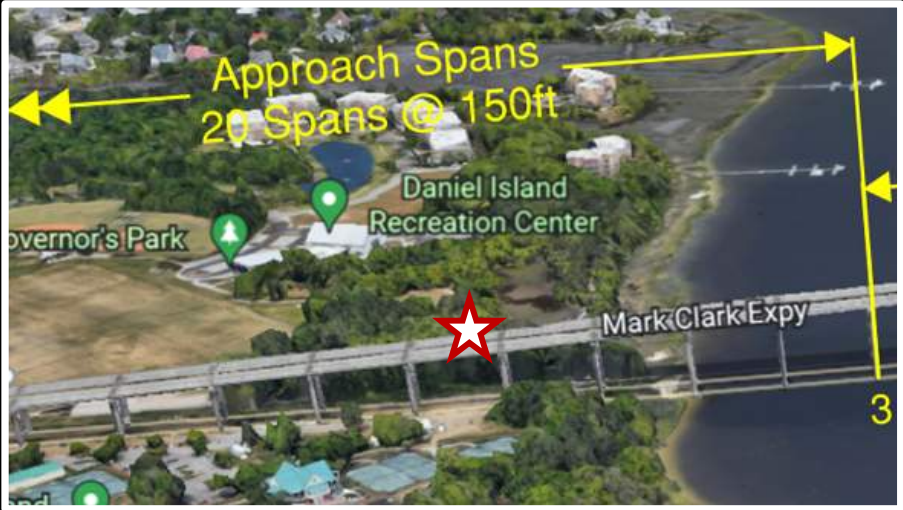
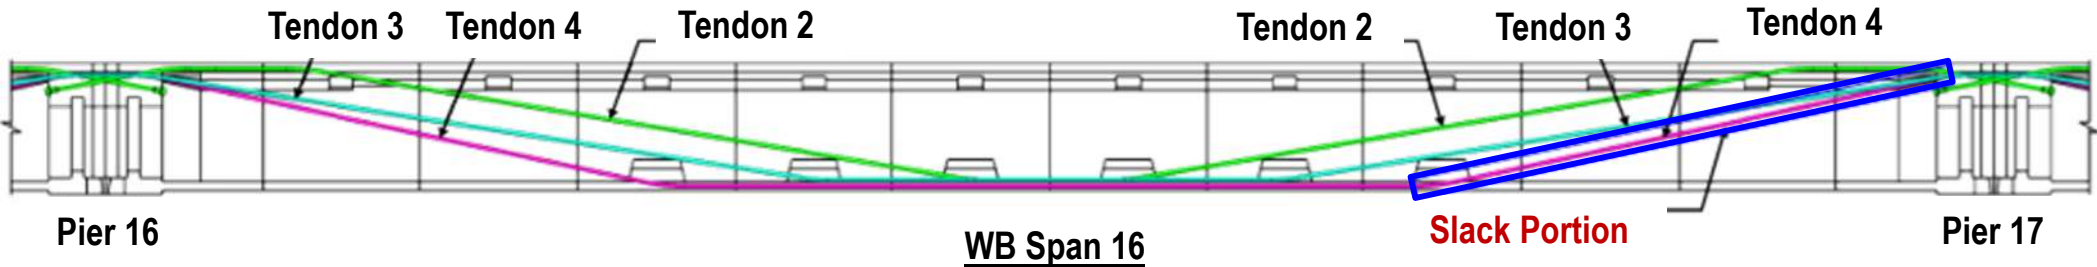
- Draped portion of **Tendon 4S** found slack
- Downstation end of tendon still had tension
- No evidence of corrosion or water infiltration of the tendon or at the diaphragm

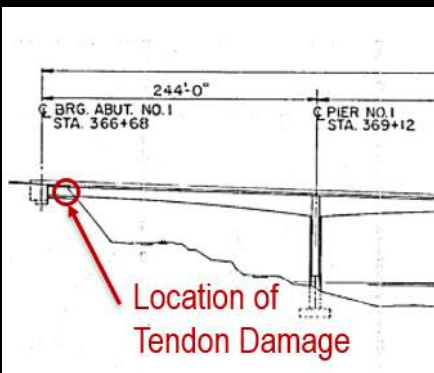
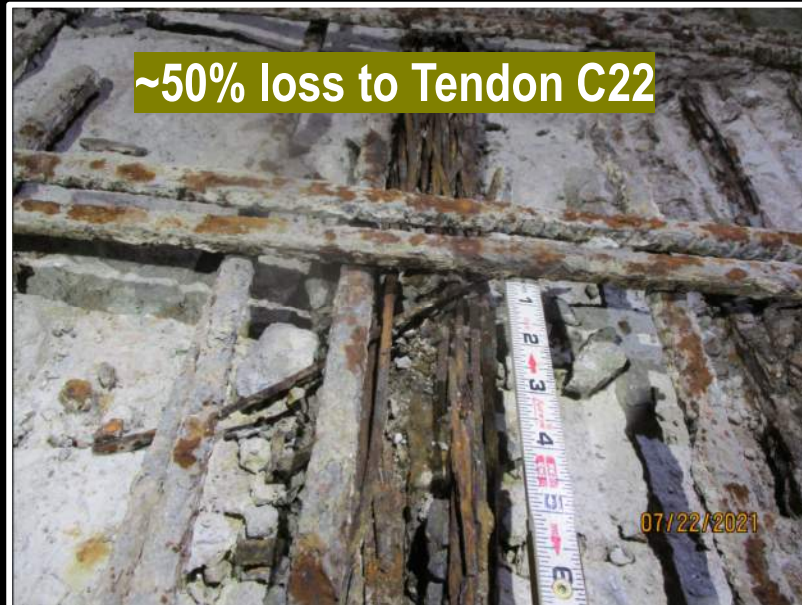
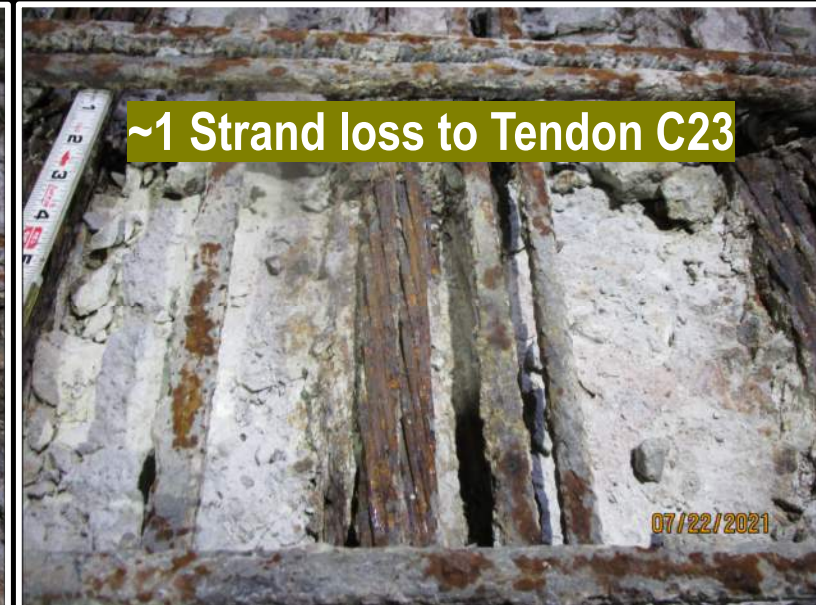
Corroded PT Tendons in Bottom Slab in main span unit

- Rainwater Permeated the Bottom Slab Over Time, Corroding the Tendons
- **Very Localized**; No Further Damage Found Along Tendons

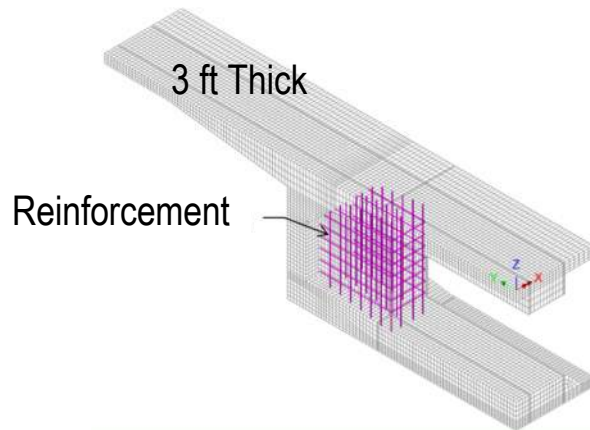
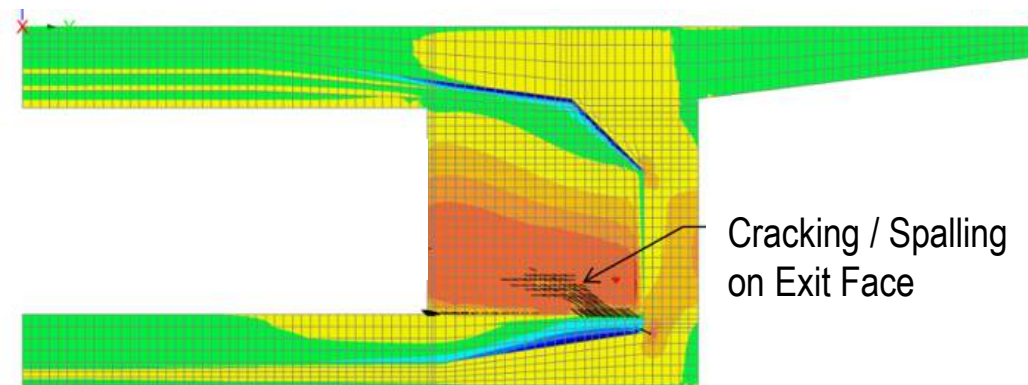
Linear Elastic Model	Plastic-Crack Model with Discrete Rebars
Purpose	To calculate a tensile force / amount of reinforcement required by the tie force.	To see how forces redistribute once cracking occurs and to calculate a tensile force / amount of reinforcement required by the tie force.
Conclusions	The reinforcement required by the tie force is greater than the reinforcement in the existing diaphragm.	The model predicted heavy cracking on the exit face of the diaphragm. We needed to extend the diaphragm.
