POST-TENSIONING TENDON REPAIRS OF TWO SEGMENTAL CONCRETE BRIDGES

I-526 James B. Edwards Bridge
over the Wando River

N-2 Missouri River Bridge

**Post-Tensioning Tendon
Inspection and Repairs**

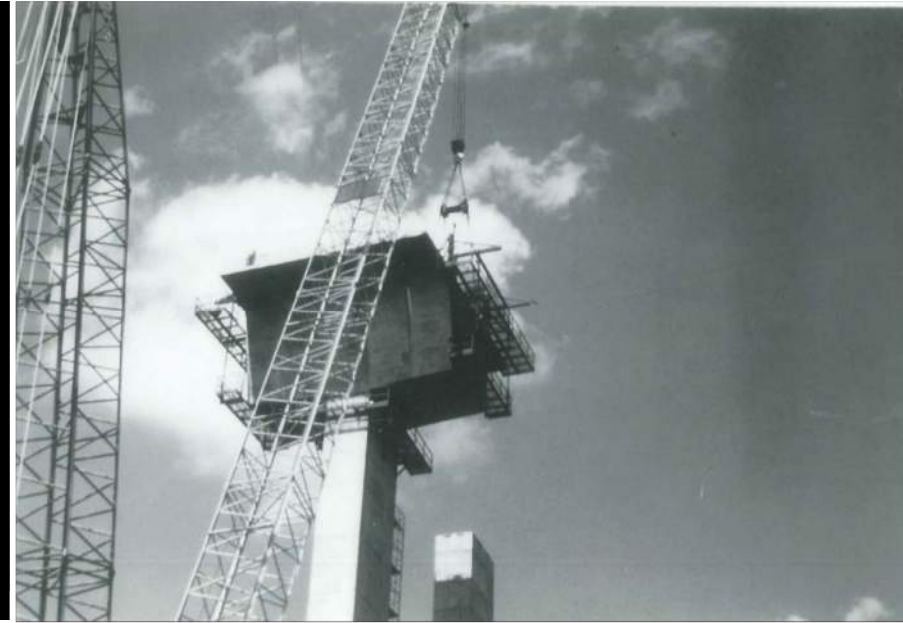
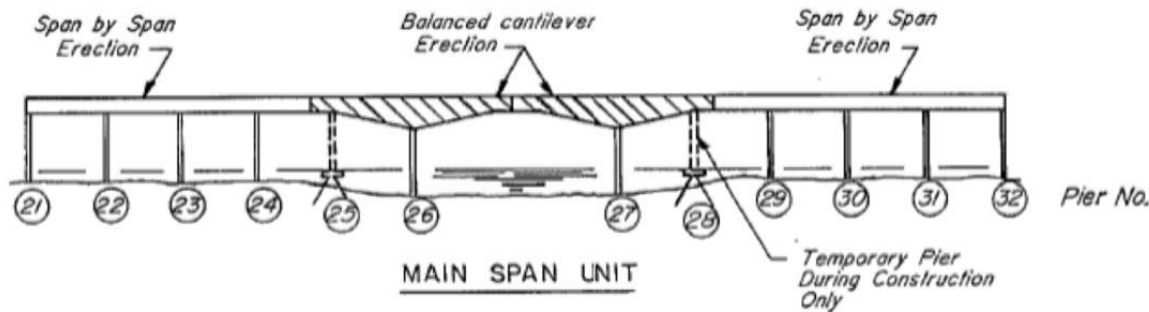
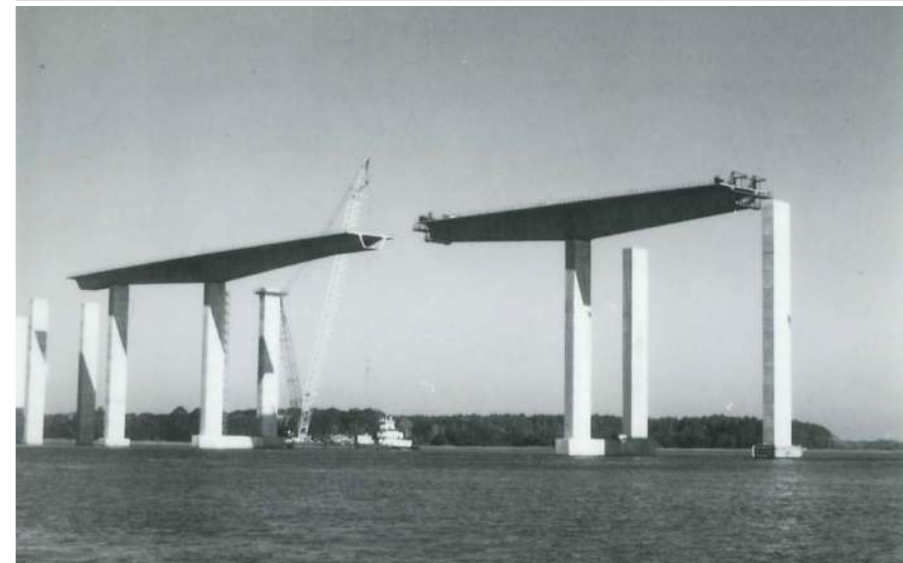
Main Span Unit

M1-R Tendon Ruptured

- 19 Strand External Tendon
- 1,010 ft long
- No other distress evident

- Near daily inspection
- Installed crack monitors at key locations
- Engaged HDR to Model and analyze main span unit
- **Closed one traffic lane to reduce load and provide a work zone on the deck**
- Installed one supplemental tendon
- Detensioned and replaced the ruptured tendon

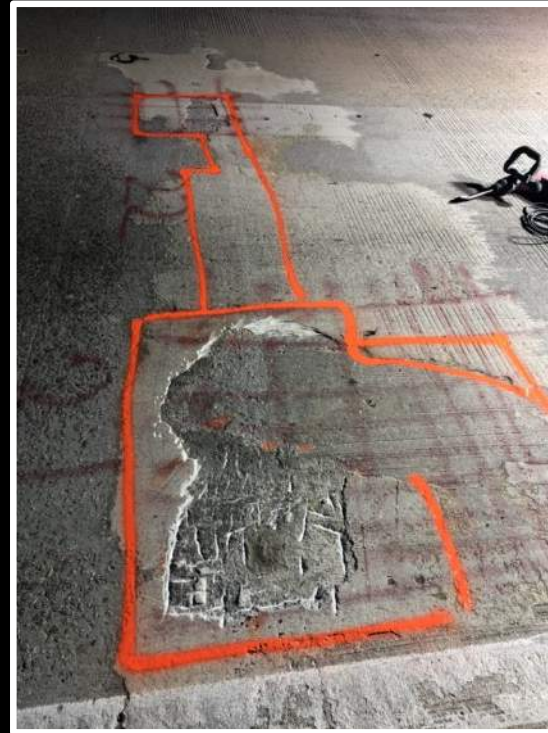
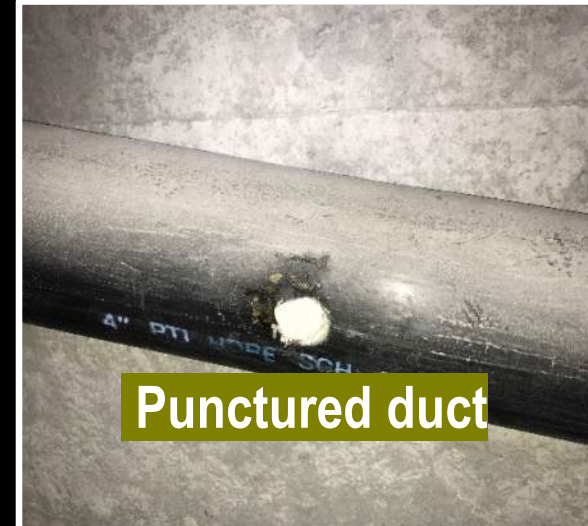
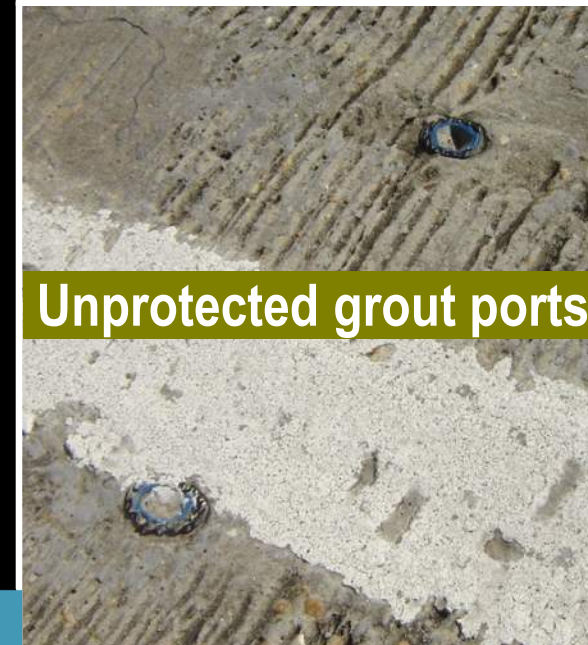
M1-R Tendon Investigation

Grout material issue?

Steel material issue?

Construction method issue?

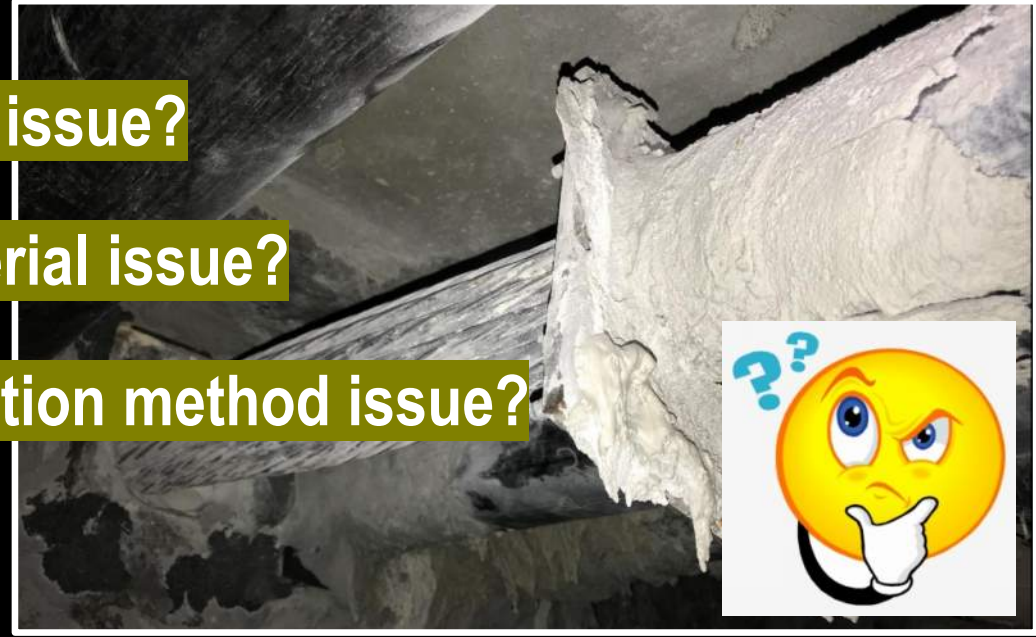
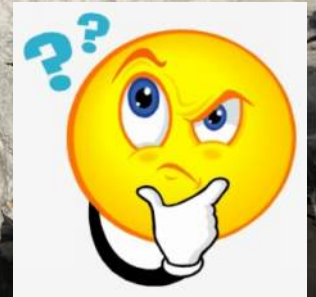
Scoping the anchors

External Tendon Assessment

Walkthrough and Visual Inspection

- Cracks, spalls, voids
- Open grout ports
- Evidence of water infiltration
- 300 borescope inspections

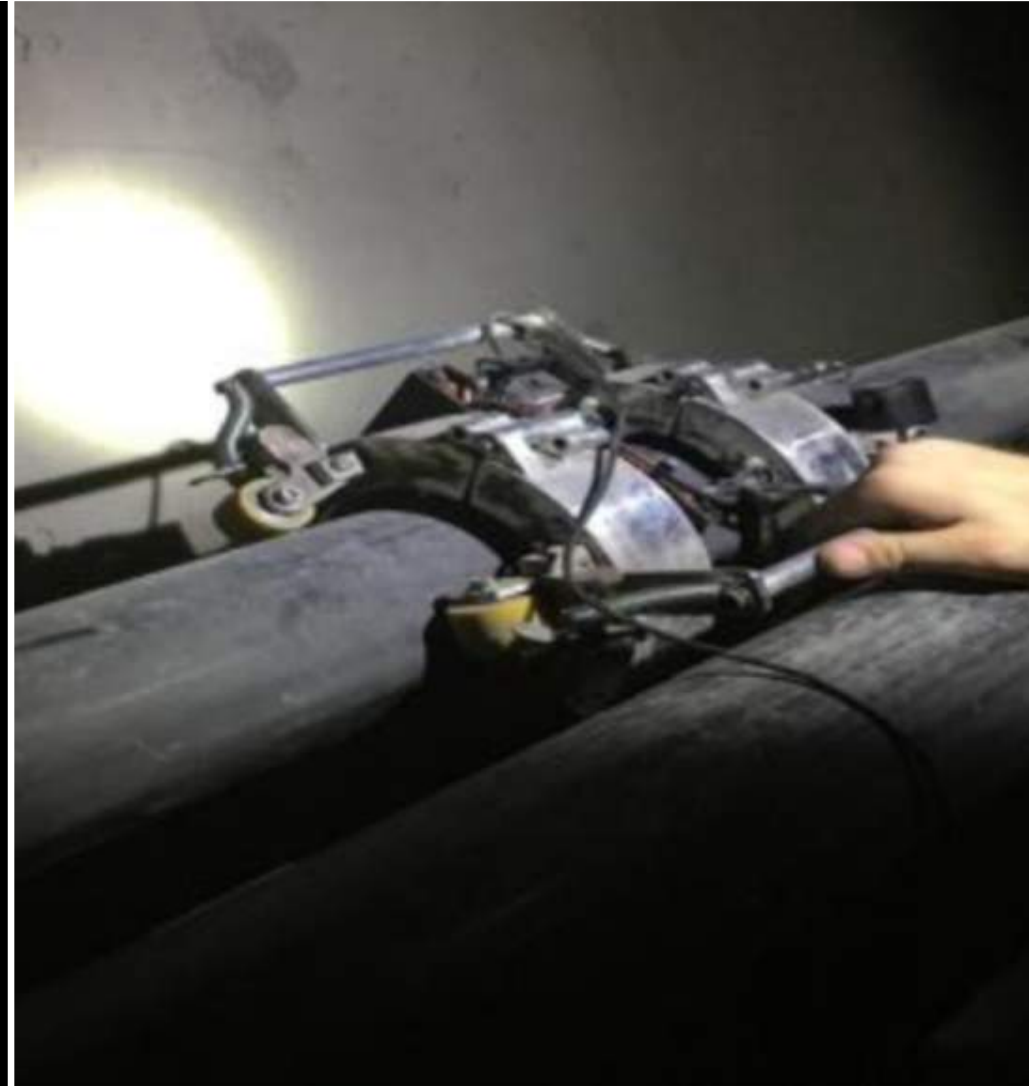
External Tendon Assessment

Capacitive Probe Inspection

- Locates voids, water, white paste, soft grout
- 44,445 linear feet tested

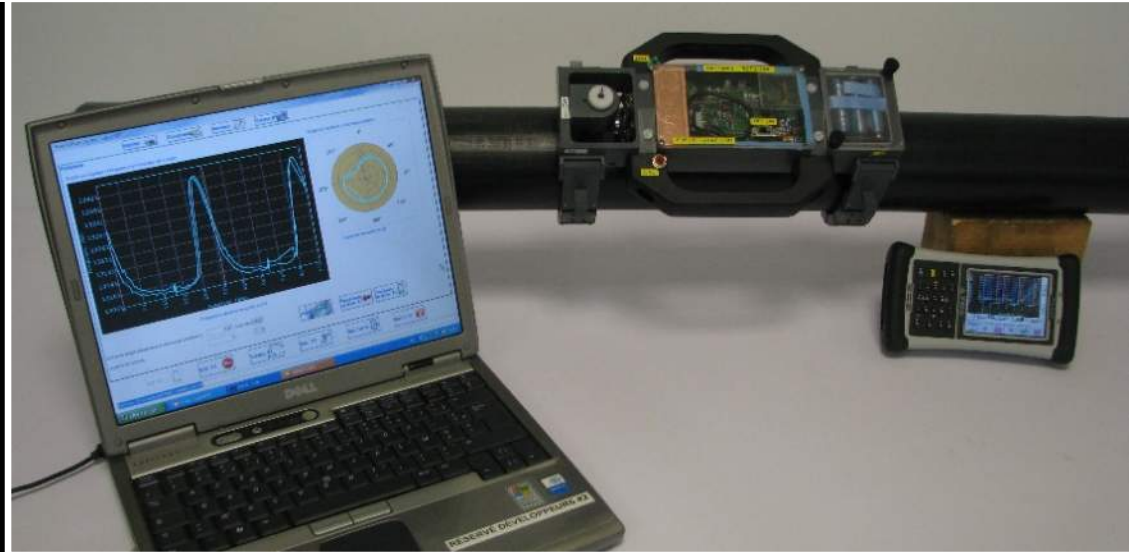
EB SP13 SD M3

Potential void

potential void on tendon

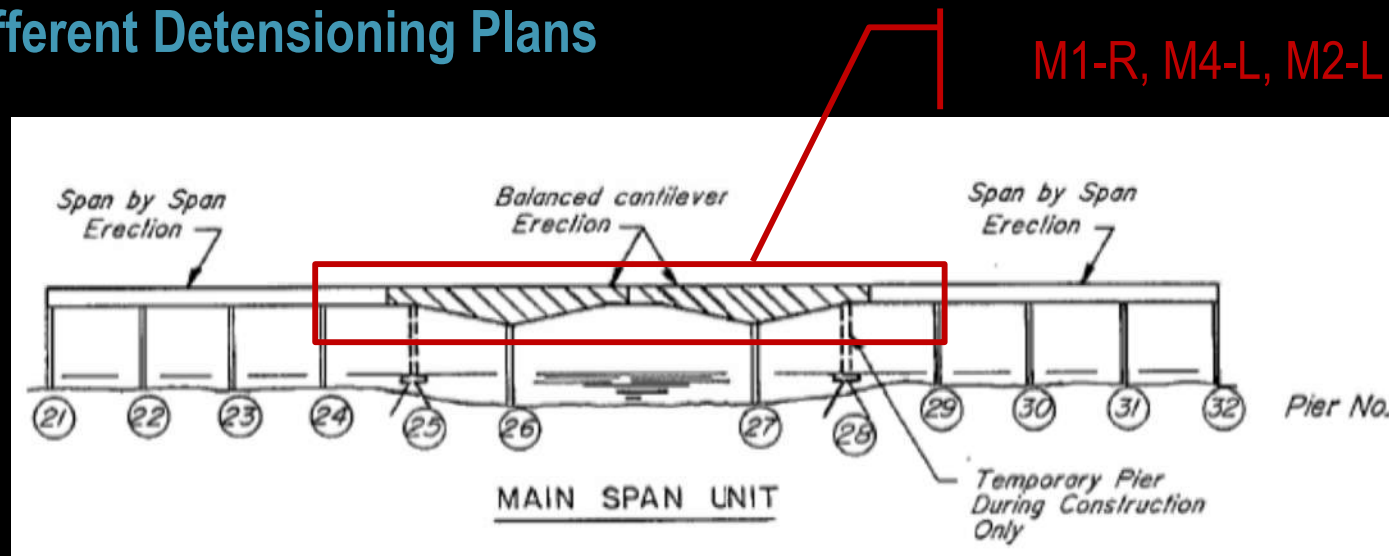
- **M1-R & M4-L** Tendons: ruptured
- **M2-L & M2-R** Tendons: completely intact, partially corroded

Detensioning of Ruptured M1-R and M4-L Tendons

Step 1: Installed heavy duty clamps every 4ft along the full length of the tendon

Step 2: Removed Grout at specific locations on either side of diaphragms

Step 3: Cut strands with powered cutoff saw alternately on either side of P26 to match broken strands at P27 and balance the tendon force.

Step 4: Cut strands at P28 to match P27

Step 5: Cut one strand at each point sequentially until all strands are cut

Step 6: Removed the tendons from the diaphragms by pulling the tails

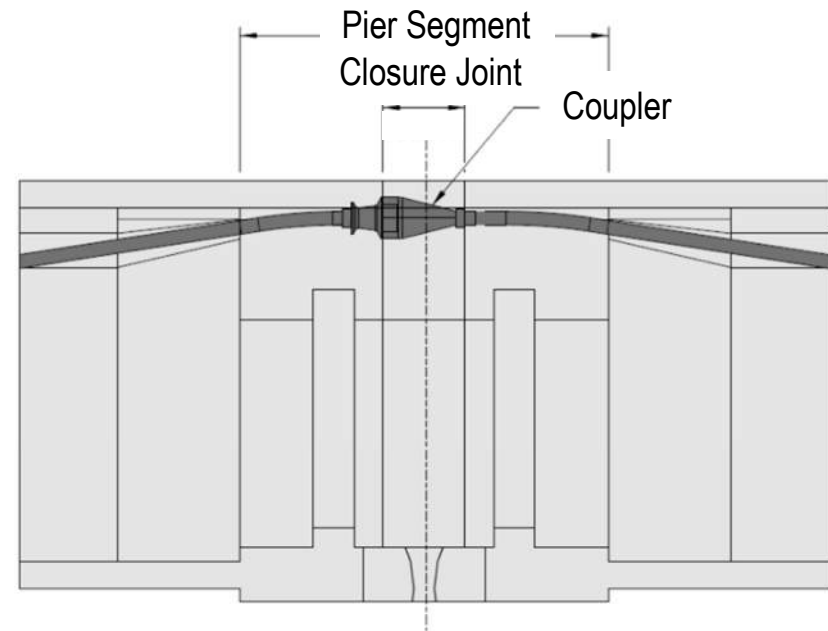
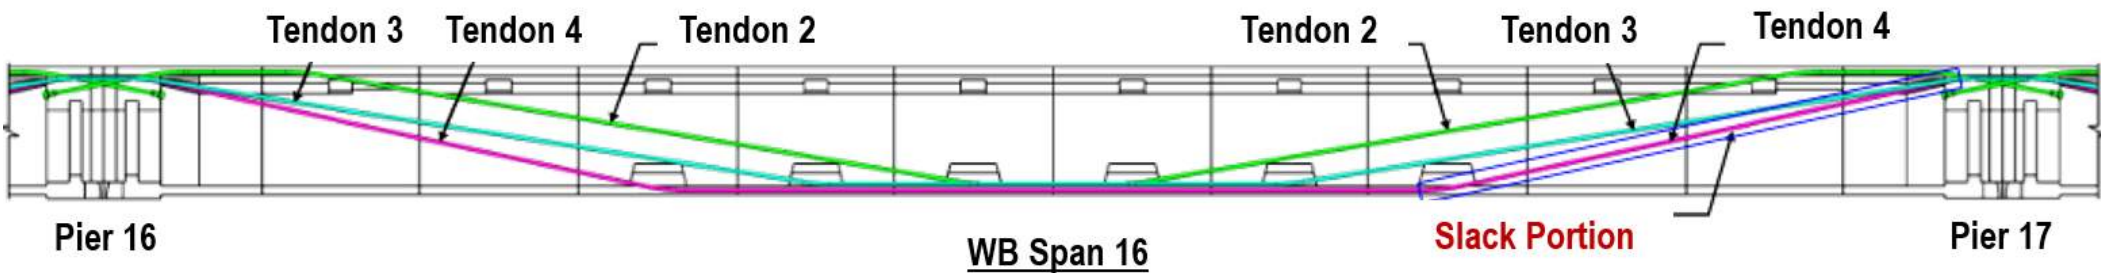
WB Span 16 Supplemental Tendons

Replacement challenges

- Tendon is coupled to a tendon in the adjacent span
- Tendon profile becomes internal to the bottom slab

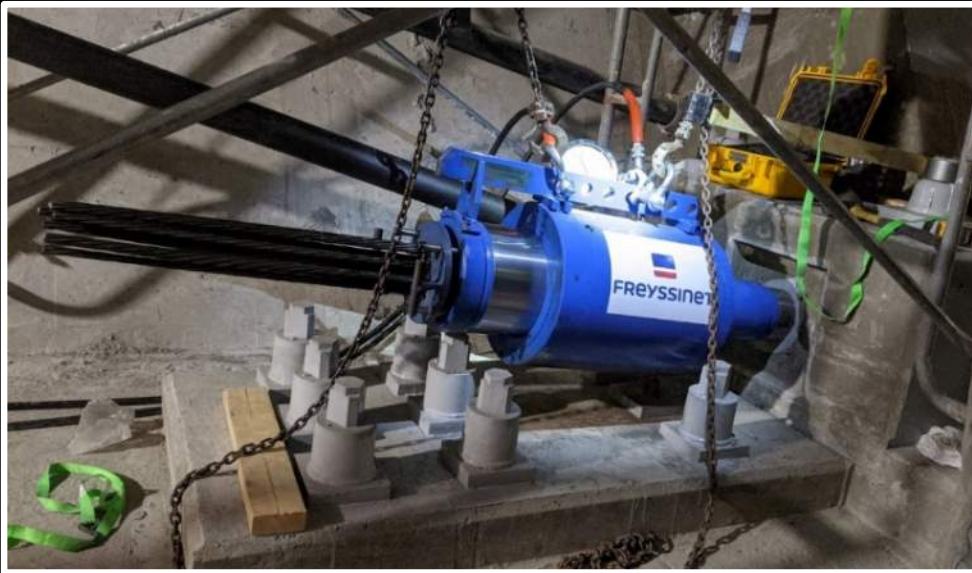
Span 16 Stressing – Fit like a glove

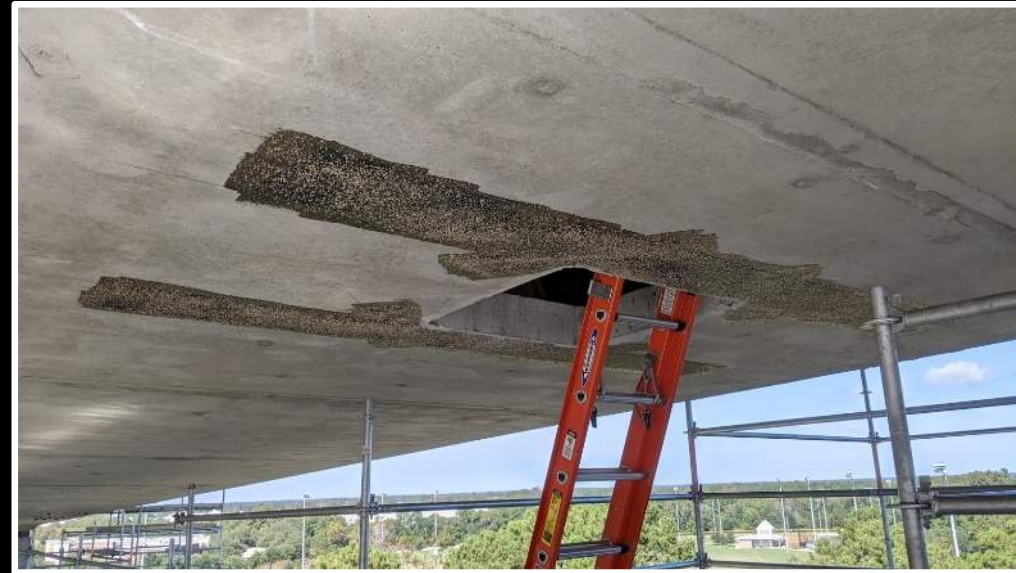
CFRP reinforcing at new access opening

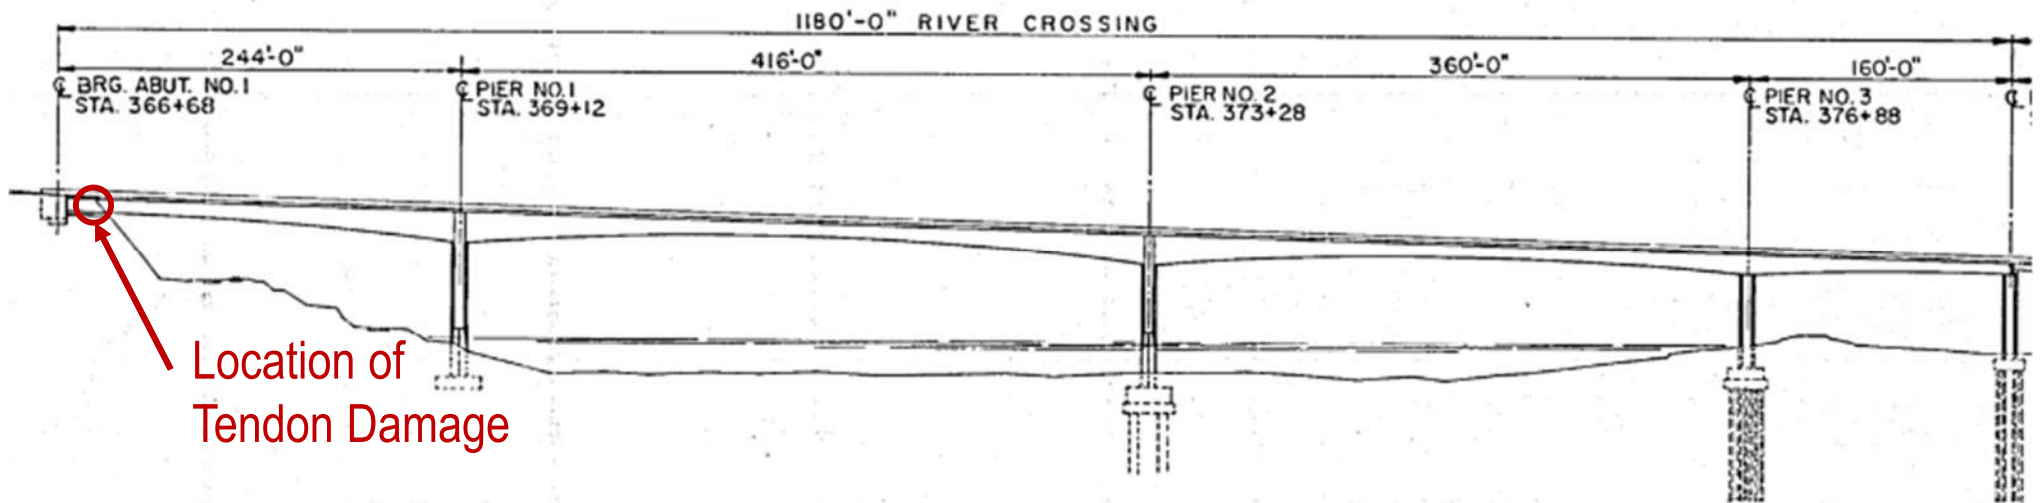
Corroded PT Tendons in Bottom Slab in main span unit

- Rainwater Permeated the Bottom Slab Over Time, Corroding the Tendons
- **Very Localized**; No Further Damage Found Along Tendons

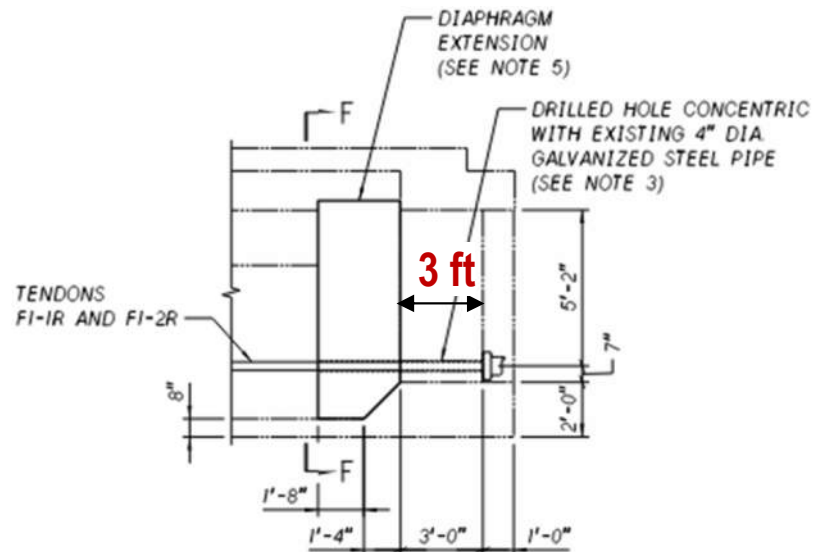
Abutment 1 Diaphragm – **Not Sufficient**

Linear Elastic Model	Plastic-Crack Model with Discrete Rebars
Purpose	To calculate a tensile force / amount of reinforcement required by the tie force.	To see how forces redistribute once cracking occurs and to calculate a tensile force / amount of reinforcement required by the tie force.
Conclusions	The reinforcement required by the tie force is greater than the reinforcement in the existing diaphragm.	The model predicted heavy cracking on the exit face of the diaphragm. We needed to extend the diaphragm.

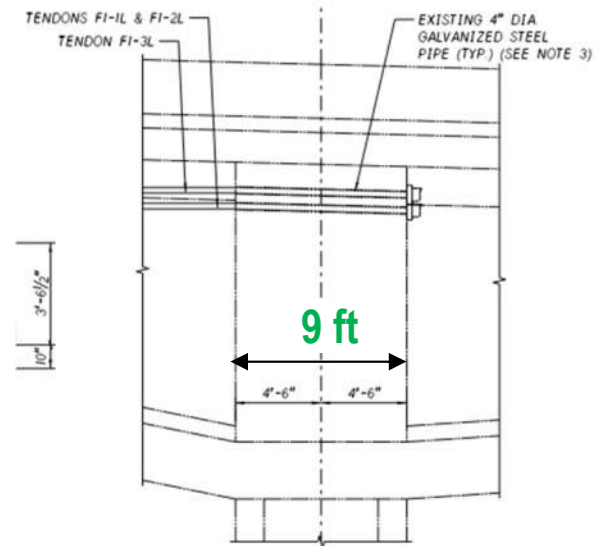
Pier 1 Diaphragm

Pier 1 Segment Diaphragm – **Sufficient**

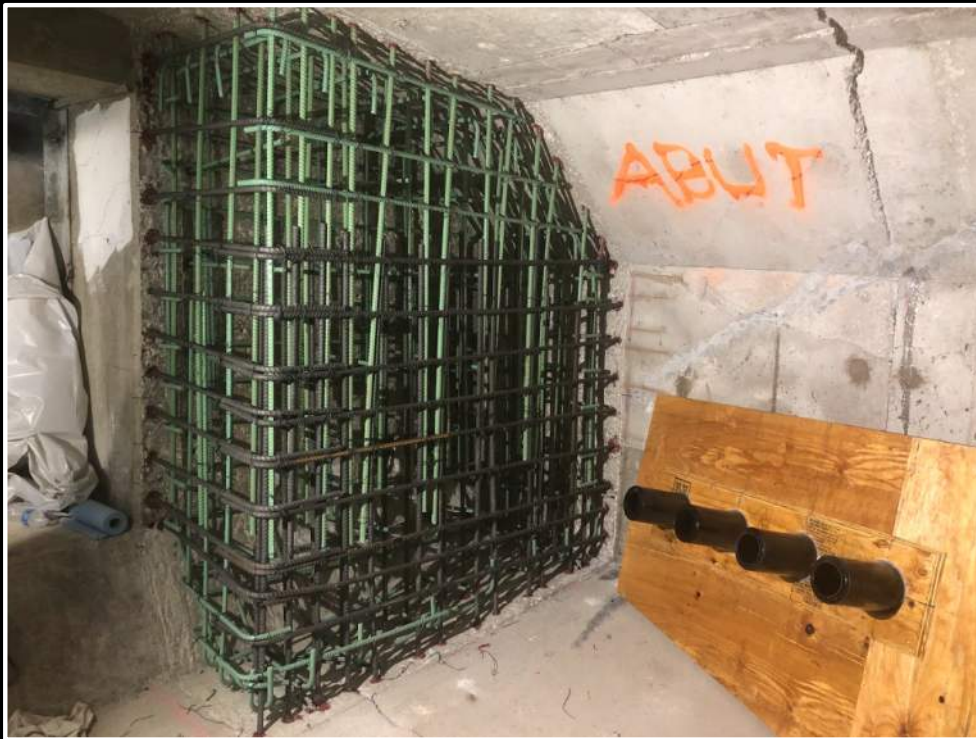
Diaphragm Extension – Rebar Cage

- Diaphragm Extended 3'-0"
- Designed Diaphragm Extension for "Future Tendons" (Used 4-12 Strand Tendons in the Model)

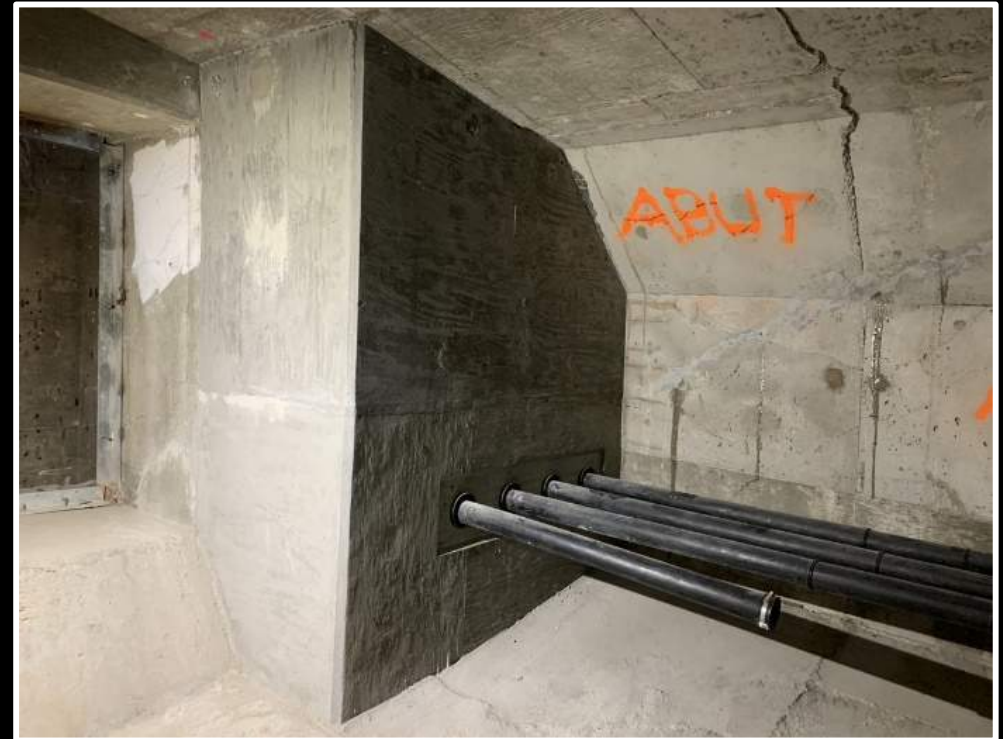
Completed Diaphragm Extension

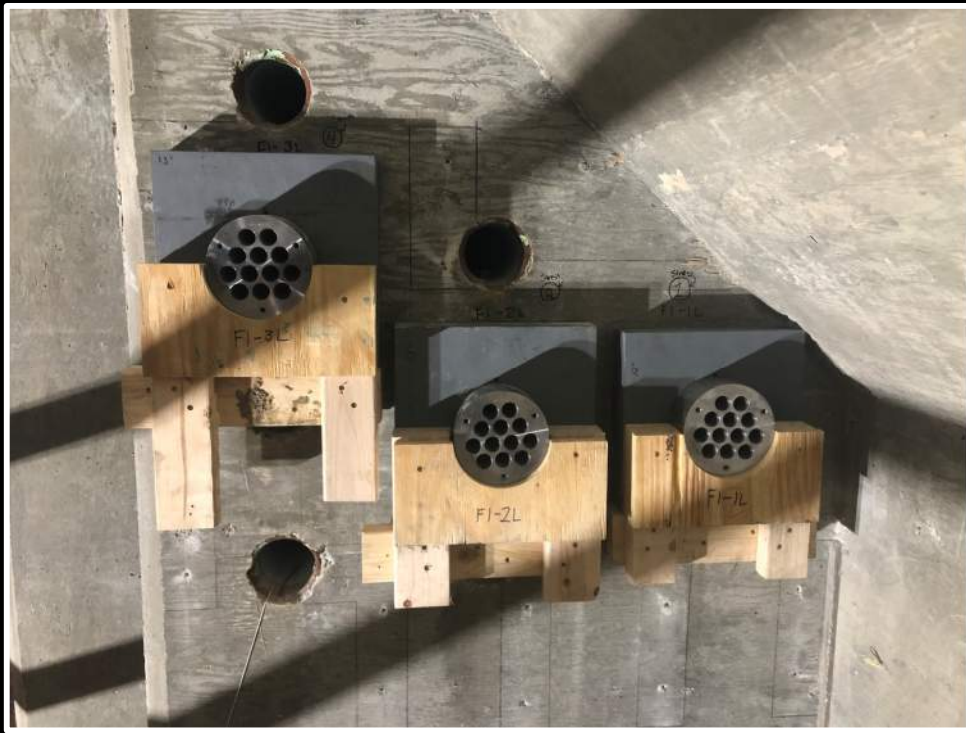
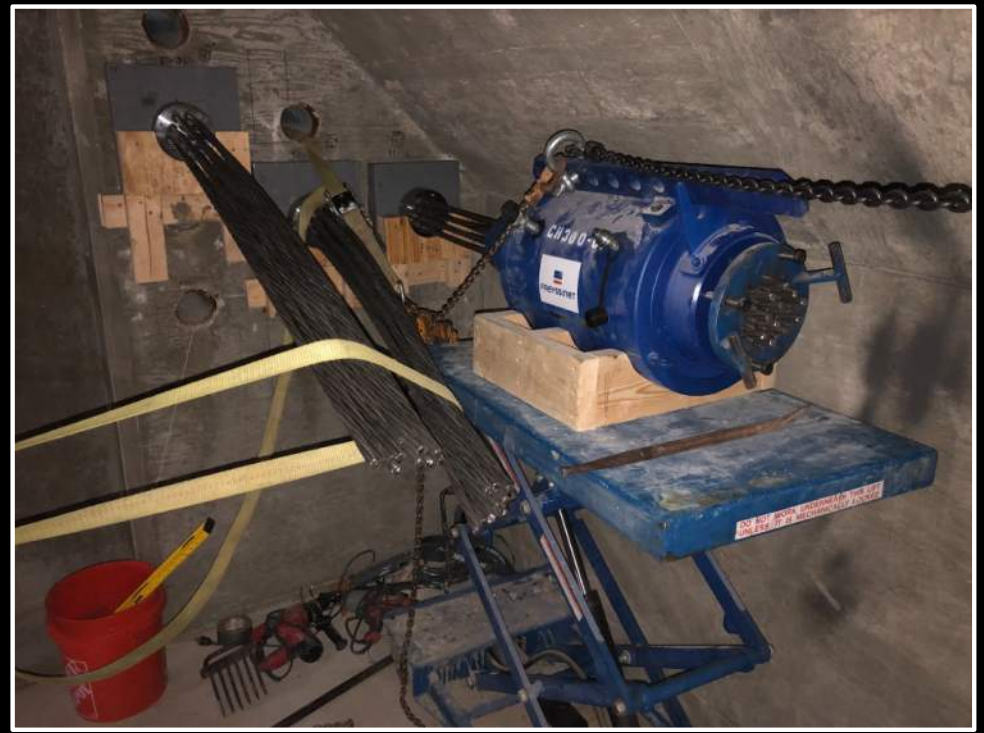
Tendon Stressing at Pier 1 Diaphragm

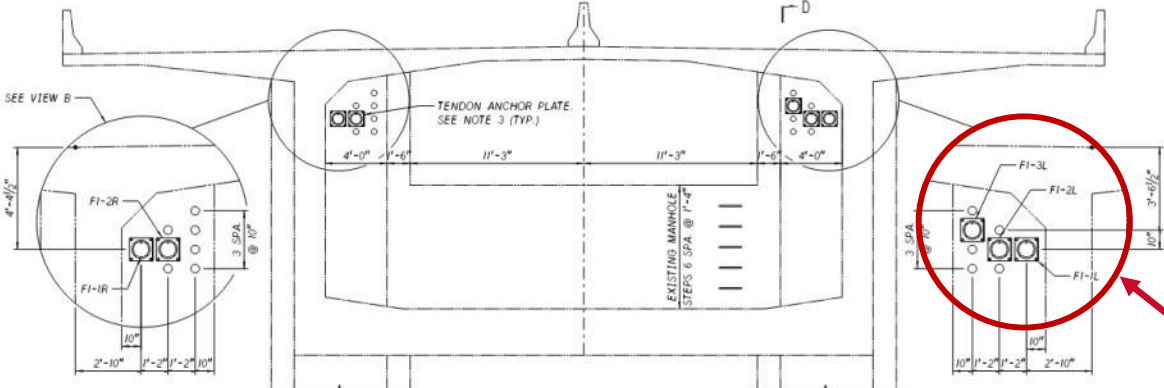
Anchor Face, Pier 1 Diaphragm
